Fire Management Statement

WALLACE BUSHLAND RESERVE, FRANKSTON

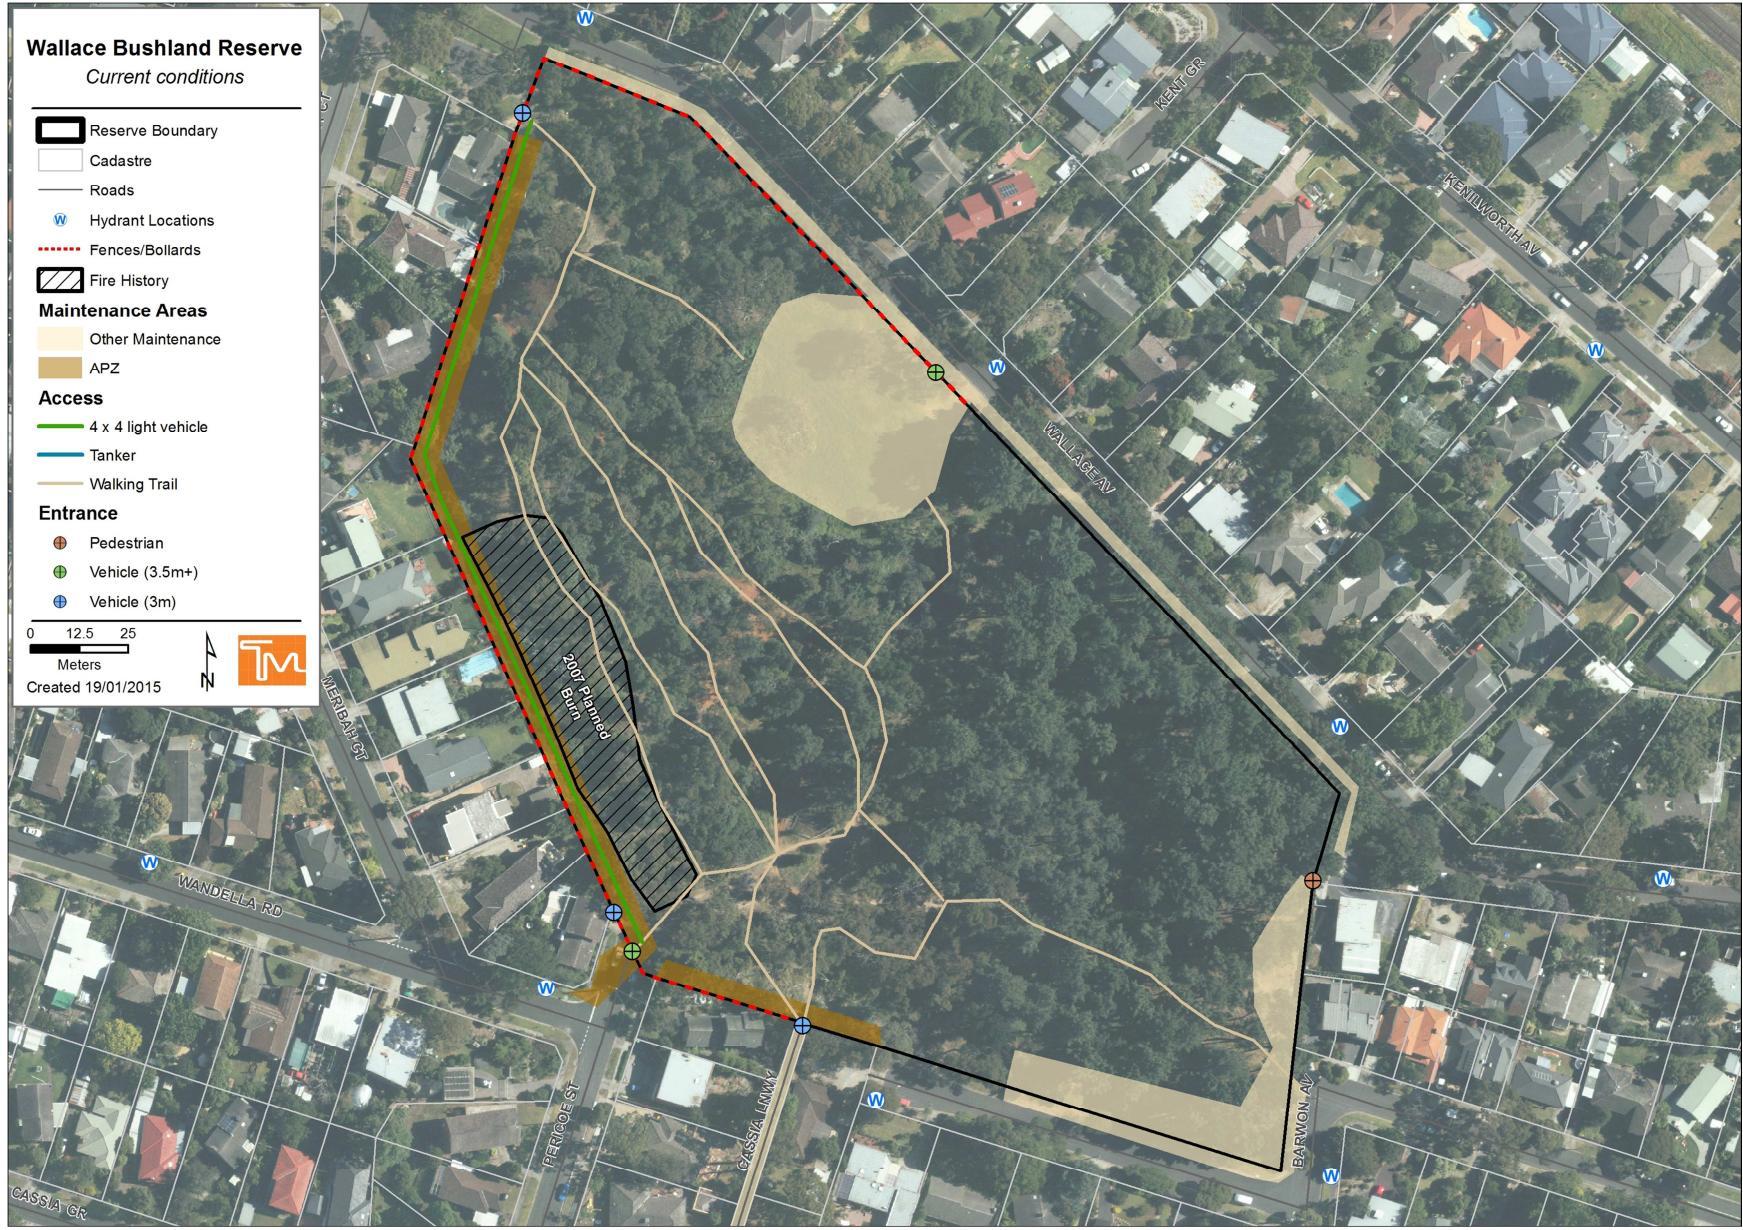
Map 1 - Wallace Reserve, current conditions and fire history

Access at Wallace Bushland Reserve is shown on Map 1.

There are four formal access points (two tanker and two light 4x4 vehicle) on the perimeter of the Wallace Bushland Reserve. Tanker access into the reserve is confined to the western APZ area. Assuming fire services are able to open all vehicle gates and tracks, and areas designated as providing access are maintained, the level of access is deemed adequate.

Water hydrants	The streets surrounding Wallace Bushland Reserve contain numerous hydrants. There are none within the reserve. (Refer Map 1)	
Static supply	There are no static water points in the reserve.

Туре	Action
Vegetation management	Maintain existing APZs and low fuel areas
Access	Maintain existing entrances and tracks to ensure both light 4x4 vehicle
ALLESS	and tanker access
Signage	None
